ATLANTIC ISLANDS Additional Photographs 2006

Santa Cruz de la Palma

Pages 248/249

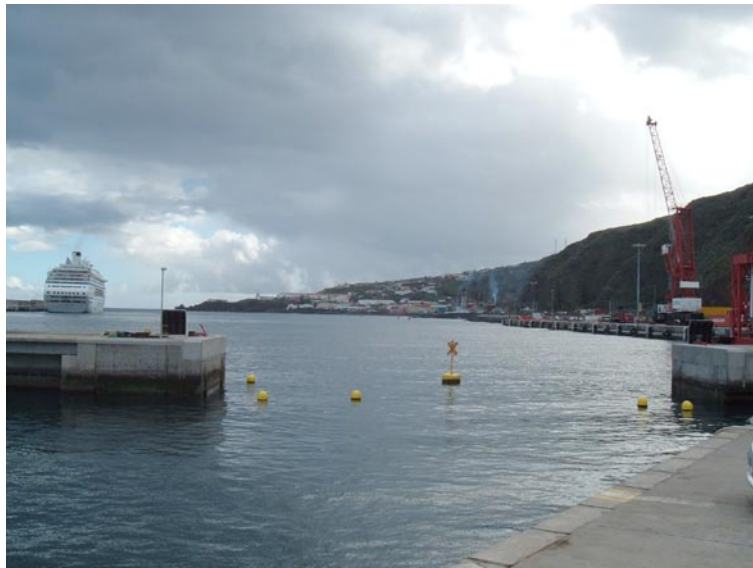
Entrance to marina at SC de la Palma is now on the west of the harbour, not the east as shown on the plan. Enter between the small yellow buoys.

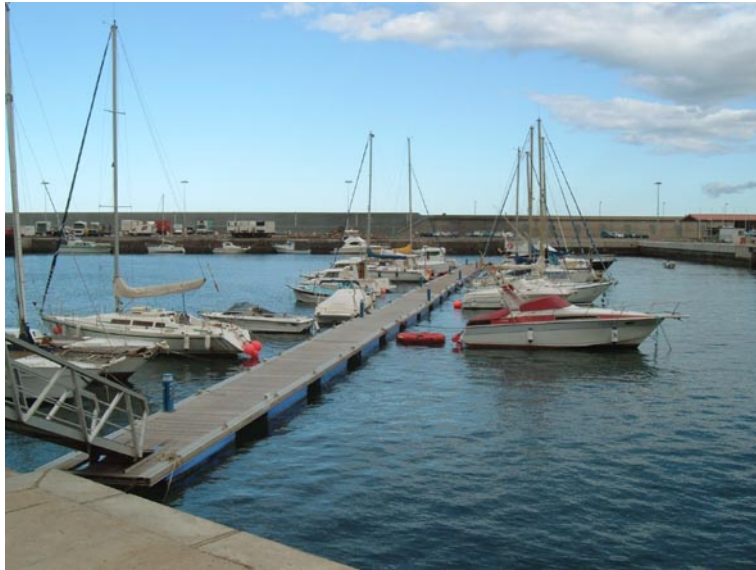
SC de la Palma Marina pontoon. Moor in Med style leaving a large gap between adjacent boats – or moor to the wall or anchor
