91 Gijón (Muelles Locales)

The main port of Asturias, with a major marina. Doubtful access in really bad weather but an all-weather alternative at Musel across the bay

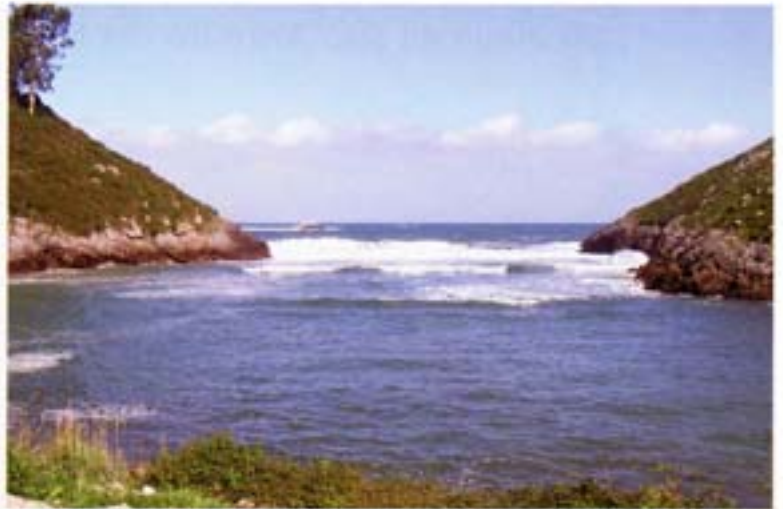
The bar near LW looking N. Isolete Peyes on left beyond

The bar has 0.5m or less on it. The best time to enter is HW-0100 to HW but it tends to break in any swell at any state of the tide. A wait in deep water to observe the conditions before commitment to the entrance will be prudent.

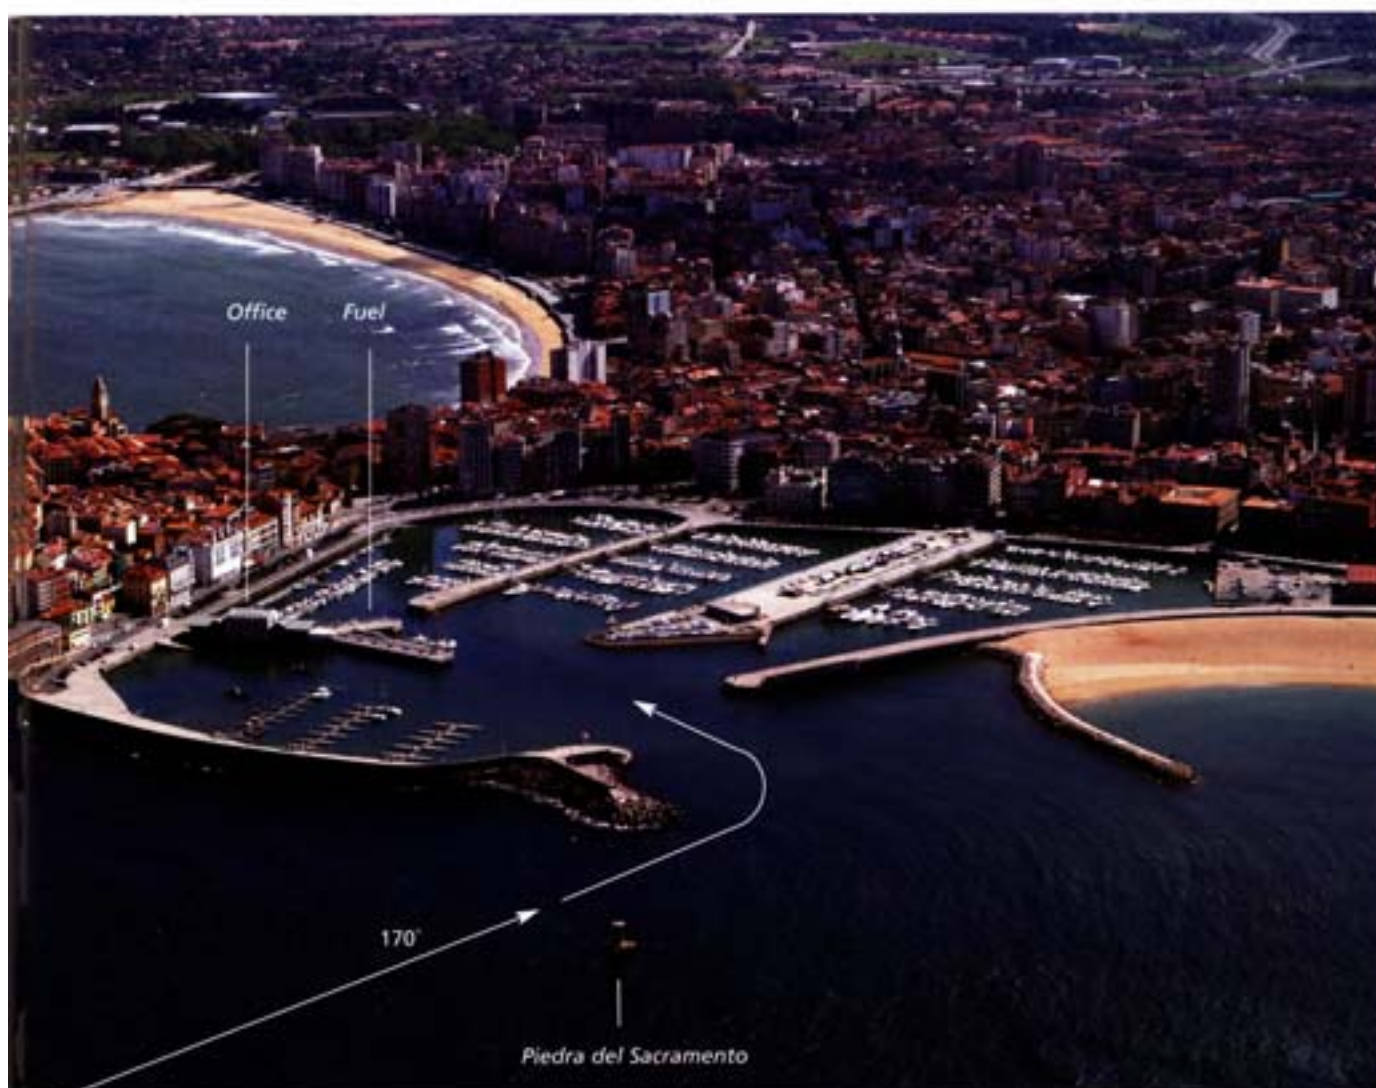
Gijón marina looking SE
